1. February 17, 2021: Use of fire extinguisher to stop a potential fire caused by a smoldering plastic bag with chemical powders

2. March 13, 2021: Full Liquid Nitrogen Tank Tipped When Moving Down Ramp Outside Forney

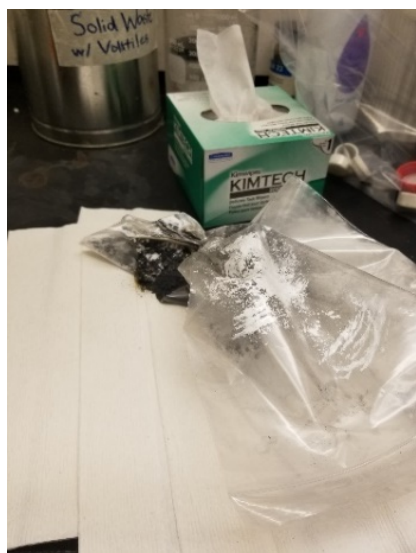
Description: As part of routine glovebox cleaning, samples were removed from the glove box and placed in the fume hood to await sorting and discarding. During this discarding process, several powders containing carbon and lithium samples were combined in a plastic bag. The samples began to react and self-heat, resulting in melting of the plastic bag and smoldering.

Immediate Action: As the bag started to smoke, the researchers used the fire extinguisher available in the lab to stop the reaction and smoldering, and to prevent a potential fire. The powders were then placed in an empty glass container in the fume hood, and this was filled with water to prevent further reaction.

- a. **Never mix incompatible waste streams**, as chemicals (even if they are in solid form) can react (sometimes violently) and lead to a safety incident (e.g.: fire, over pressurized vessels, explosion, etc.). If you are unsure whether your waste streams are compatible or not, treat the streams as incompatible and dispose of them separately.

- b. Use appropriate containers to collect waste (inert to the waste stream), as plastic bags are not compatible with all chemicals.
- c. As lithium was involved in this incident, it was recommended that waste powders containing lithium metal (which can react violently with traces of water and even with the humidity in the air), are covered with mineral oil while still in the glove box, before being taken out for disposal.

- d. Although the researchers were confident that they can manage the smoldering using the fire extinguisher, in case of a fire (or smoldering in this case), **the proper procedure is to call 911 to report the incident, and only after that use the fire extinguisher.** Alternatively, call 911 while someone else is using the extinguisher. In any case, the fire department needs to be informed that a fire extinguisher was used in the lab.

- e. The group will develop Standard Operating Procedure (SOP) for safe disposal of Li metal containing samples and train the whole group on safe procedures.

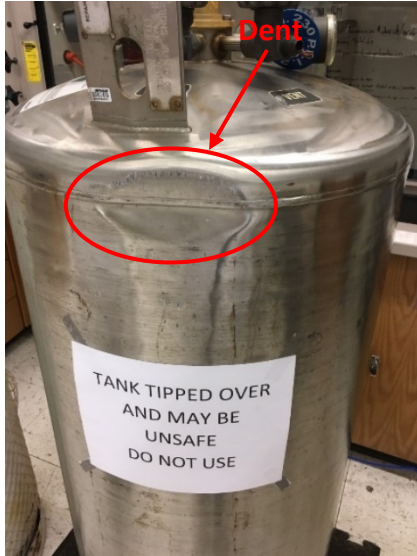
While the researcher was pushing the loaded cart down the ramp outside Forney, he lost control of the cart as it went over a "bump" located midway down the ramp. The bump, which is a small drop-off between two concrete slabs, caused the front wheels of the cart to drop unexpectedly, shifting the weight of the cart and

tipping it forward. This caused the cart and tank to flip forward and crash down on the ramp. Fortunately, no one was in the path of the falling LN2 tank, so no one was injured. The tank did not start to vent.

- The researcher acted correctly by not trying to stop the falling LN2 tank.
- Even though the so called “bump” was repaired during fall 2020 (the concrete slab was grinded to the level at which it did not pose a safety concern anymore), a close visual inspection of the revealed that the concrete swelled during the cold weather this winter, and now there is an uneven transition between the two adjacent concrete slabs, which is a safety hazard.

- The researchers were not aware of the procedures set by the ChE Safety Committee which state that full LN2 tanks should only be brought in the building via the lifting platform at the receiving area (during normal business hours), and the ramp should not be used for this purpose AT ALL, due to the heavy weight of a full LN2 tank.

Although theoretically there were 2 people present during the transportation of the LN2 tank, one person took the stairs, thus practically only one person was handling the full LN2 tank on the ramp, which is the most dangerous part of the trip. However, upon closer inspection, it was determined that the LN2 cart could not be handled safely by two people due to the size of the cart and width of the ramp.

Immediate Action: Due to the heavy weight of the full tank, which can weigh between 600-800 lbs., the researchers were not able to bring the tank to upright position on their own, thus called two other members of the group to assist with this task. When the tank was in upright position, the four researchers inspected the tank visually and noted that the pressure in the tank was 90 psi (the pressure relief valve vents at 230 psi), and there was a large dent (~6" x ~3") on the upper corner of the tank (see picture to the left). The extent of the internal damage to the tank is unknown, but it was assumed that the tank was no longer safe to use. It was also assumed that the liquid nitrogen in the now-damaged tank possibly represented a hazard if allowed to build pressure over time. Therefore, the researchers slowly vented the contents of the tank outdoors, periodically pausing to ensure that nitrogen had a chance to dissipate. The tank was then brought into the lab and decommissioned, and it will be returned to Praxair.

- The ChE safety committee will discuss this incident in the upcoming meeting in March and will update the “Gas Cylinder Handling Procedures for FRNY Building” document to include updated verbiage regarding timing of transportation of LN2 tanks into the building.

- The Physical Facilities department was asked to grind the raised concrete slab in the ramp at a smaller slope, to ensure a smooth transition between the two adjacent slabs.

- ❖ The remaining LN2 tanks requiring the use of a cart for transportation will be returned to Praxair, soon.
 - ❖ Only the existing wide, short 230L LN2 tanks with attached wheels will be kept for in-house filling (at Physics LN2 farm). These tanks can be easily handled by two people, unlike the one-person cart used during the safety incident.
