I would like to share with you a few safety incidents reported to me between December 2021 and February 2022. Near misses reported, such as laboratory broken vessel or small, incidental spills are not mentioned in this document. However, please use caution and don't rush through tasks while working in the lab, as this can easily lead to more serious safety incidents. It is important to promptly report safety incidents and near misses after they occur to ensure the safety of everyone in the department. No one will ever get in trouble for reporting a safety incident as it is a way to help keep our research community safer.

### 1. July 10, 2021: Hastelloy Tubular Reactor Sudden Pressure Release/Explosion (reported February 14, 2022)

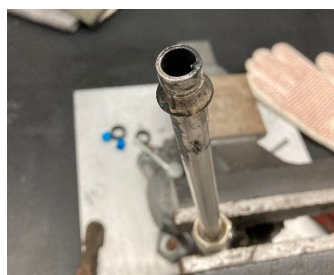
Description: A 25 mL hastelloy tubular reactor was loaded with 10 grams of rare earth magnet, 0.015 g of NaCl and 15 mL of DI water, sealed following the Swagelok cap assembly procedure and placed in a muffle furnace at 250 °C for 18 hours. The reactor was then cooled to room temperature and fixed on a bench vise to be opened. When the top-side cap screw was loosened, the inside pressure caused by reaction products was suddenly and violently released (explosion like), and the cap hit the ceiling. The magnet pulverized in the reactor and spilled on the safety goggles, the mask, and the lab coat of the researcher opening the reactor. The researcher did not suffer any injuries.

- b. When opening potentially pressurized reactor vessels, always point the cap away from any researchers to ensure that the cap does not injure anyone.

- c. When performing pressurized reactions, it is important to account for gasses that may be produced during the reaction that may keep the reactor pressurized even after cooling.

- d. If the group is continuing work using this method/reactor type, the safety committee is recommending the following:
  - a. add a custom-made pressure relief valve to the reactor, use a larger reactor, or scale-down the reaction to 10% of the original quantities to prevent pressurization in the future.

- b. develop an SOP for operating the hastelloy reactor and consider all potential hazards before starting operation. Add engineering controls to the unit and have everyone in the lab trained on this SOP.

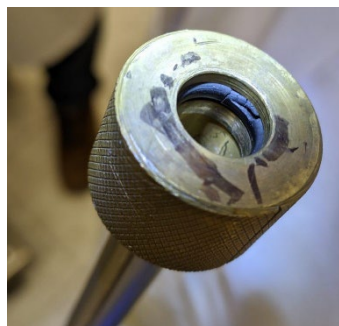
### 2. December 09, 2021: Liquid Nitrogen Leak in Transfer Line

Description: A researcher was performing temperature-dependent current-voltage measurements on a Lakeshore system. These measurements involve using an insulated transfer line to allow liquid nitrogen to flow from a tank into the Lakeshore system. After using the transfer line for ~8 hours, the researcher saw a large

volume of nitrogen gas leaking from the flow control valve of the transfer line. Using cryo-gloves, the researcher tried to close the flow control valve, but that seemed to make things worse. After ~2-3 minutes, liquid nitrogen started leaking (~2-3 ml per sec) from the flow control valve itself.

Results of investigation: Knowing that nitrogen should not have leaked from the transfer line, the researchers disassembled the transfer line to look for possible reasons behind the malfunction. They determined that an O-ring in the transfer line was damaged.

When working with cryogenic liquids or any chemicals or gasses, it is important to regularly inspect the equipment being used and ensure that any components that may wear down, such as O-rings, are replaced promptly when the first signs of damage are noticed.

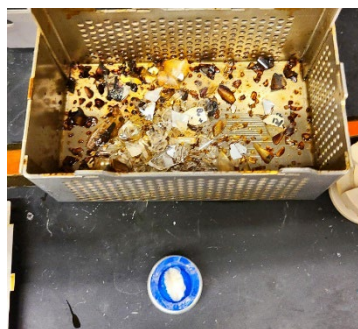
### 3. December 12, 2021: Microwave Vial Explosion in Microwave Reactor

Description: A researcher was running a 24 hour microwave reaction at 250°C. They started the reaction on Saturday evening and the instrument would automatically stop the reaction on Sunday evening. This reaction was similar to many the researcher had done in the past, with the key difference being the use of a new sulfur source, carbon disulfide. He monitored the reaction for 1 hour, by which point the temperature and pressure seemed to have stabilized. Then the researcher left for the evening.

The microwave reactor was programmed to monitor and control pressure and temperature. If pressure exceeded 15 bar, it would automatically lower the temperature such that the pressure would have a maximum of 15 bar. The reactor would automatically shut off if the pressure reaches 20 bar. Despite these safety features being in place the microwave vial exploded and completely shattered 21 hours into the reaction. This explosion took place even though the pressure in the vial never exceeded 15 bar.

- a. While the cause of the explosion is unknown, it is always important to inspect all glassware being used in reactions for defects or cracks before use.
- b. When running an experiment with a long reaction, it is important to ensure steady state is reached before leaving the reaction unattended and one should supervise the reaction for longer than usual whenever a new chemical or new procedure is being used.
- c. Pressure and temperature sensors on reactors should be regularly inspected to ensure they are operating correctly.

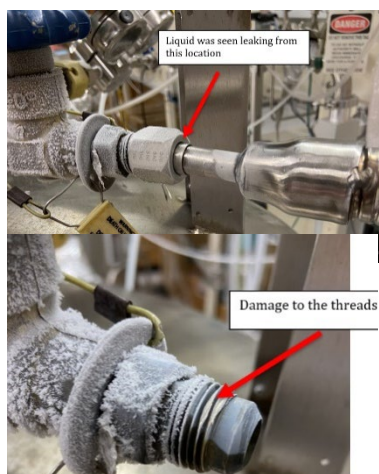
#### 6. February 7, 2022: Liquid Nitrogen Leak from LN<sub>2</sub> Tank Liquid Connection

Description: When a researcher was filling a Dewar with liquid nitrogen using a liquid transfer hose, they noticed that some liquid was spraying from the threaded connection between the hose and the tank.

Immediate Action: The researcher immediately turned off the valve to stop the flow and investigate. They unscrewed the hose and found that the threads on the liquid nitrogen connection on the tank were damaged. The threads on the hose itself seemed to be in good condition. The researcher posted a sign on the affected tank to prevent other users from using this connection and to notify Indiana Oxygen of the issue. The damage may have occurred while the tank was being filled by the vendor, or it may have occurred in the lab when someone was connecting a hose to the tank.

- a. For any gas cylinder or LN<sub>2</sub> tank, it is important to inspect threaded connections prior to connecting them to ensure that the threads are intact.
- b. It is important to pay attention to the way a threaded connection moves while screwing the two halves together. Most regulators should be attached to a tank by screwing in until finger tight followed by 1/8<sup>th</sup> of a turn using a wrench.
- c. This near miss also highlights the importance of wearing a face shield when dispensing liquid nitrogen. Had the LN<sub>2</sub> port been pointed towards the researcher, the face shield would have been the last line of defense in preventing LN<sub>2</sub> from spraying on to their face.
