I would like to share with you a selection of the safety incidents/near misses reported for our building from January, 2016 to date.

On behalf of the ChE Safety Committee

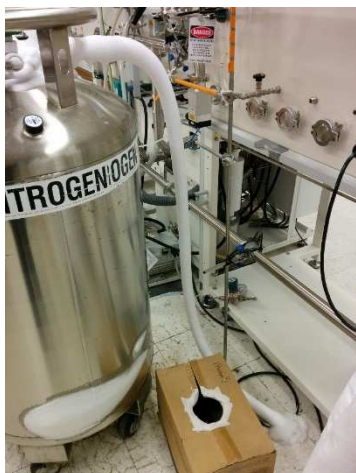
8. May 16, 2016: Leaking cryogenic fluids on power cables

Description: When entering the lab, a researcher found that the LN2 tank was leaking at a low rate causing significant condensation on the liquid feed line and was freezing over a power cable for the a glovebox (see photo below). The researcher put on cryogenic gloves, closed the valve, and carefully moved the line into the cardboard Dewar holder box. The cable did not appear to be damaged, but exposure to cryogenic liquids could have caused cracking of the cable's insulation.

Likely cause: line was not tightly closed after previous use. During glove box purging, the tank cools and the metal contracts which may have allowed a small amount of liquid to pass through the valve.

Recommendations: Always place the liquid line in an appropriate container (preferably not a cardboard box) after use and ensure that the valve is tightly closed after use.
