I would like to share with you a few safety incidents reported to me between April 2022 and June 2022. Near misses reported, such as laboratory broken vessel or small, incidental spills are not mentioned in this document. However, please use caution and don't rush through tasks while working in the lab, as this can easily lead to more serious safety incidents. It is important to promptly report safety incidents and near misses after they occur to ensure the safety of everyone in the department. No one will ever get in trouble for reporting a safety incident as it is a way to help keep our research community safer.

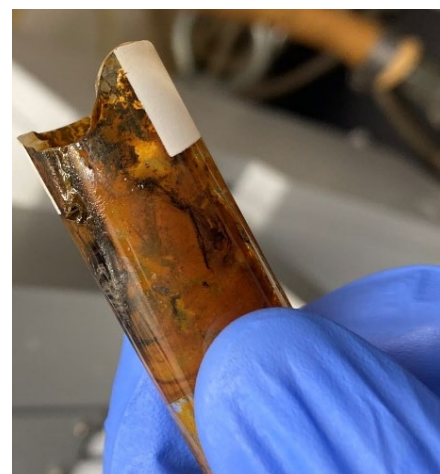
2. May 02, 2022: Microwave Vial Leak from Borehole in Microwave Reactor

Description: A researcher was performing a nanoparticle reaction with the intent of forming indium selenide nanoparticles. The initial conditions were to run the reaction for 5 hours at 250 °C. At ~2.5 hrs, the microwave cut the power due to an error indicating pressure had increased to unsafe levels (the pressure curve on the screen had indicated otherwise). The researcher decided to collect some of the reaction product for characterization and proceed to "finish" the reaction with the remaining product. After ~1 hour, the microwave cut the power again due to a sudden decrease in pressure indicating a vial rupture/leak. Upon opening the microwave lid and pulling out the vial, the researcher found a borehole caused by solid material superheating on the wall of the vial.

Immediate Action: Initial inspection showed that the vial holder was stuck in the vial as the borehole was just beneath where the holder body ends. Upon trying to file down the borehole to remove the vial holder, the vial broke into two pieces. No shards or jagged edges formed as a result. The researcher removed the vial holder and discarded the glass waste. Due to the incident occurring later in the day, the researcher notified the group that the microwave was not to be used until it had been investigated and properly cleaned. The superuser of the instrument investigated it the following morning and found no damage to the microwave. After the spilled/leaked material was cleaned, the group was notified that the microwave reactor was safe to use again.

- When performing microwave reactions, ensure that mixtures are well dissolved/dispersed and that no solid material is trapped on vial walls.
- Ensure solvent levels are above manufacturer recommended minimum
