I would like to share a few safety incidents/near misses reported to me from January 2024 to date. Some near misses, such as laboratory broken vessel or small, incidental spills are not mentioned here. However, please use caution and don't rush through tasks while working in the lab, as this can easily lead to more serious safety incidents. Please report safety incidents and near misses promptly, and discuss them in your group meetings. Be assured that no one will ever get in trouble for reporting safety incidents and near misses; these are learning opportunities that help prevent similar events from happening in the future and make our research community safer and.

1. January 22, 2024: Plastic tube damaged potentially by exposure to bromine

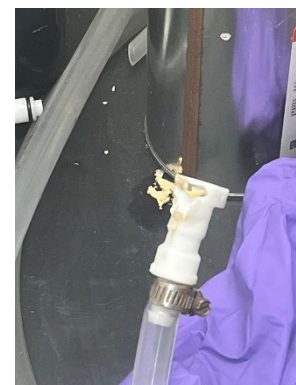
Description: While removing a waste bag located in the fume hood, a researcher noticed that a plastic tubing used for a thermostat nearby is damaged (see picture to the right). The tubing was close to a can containing 99% bromine. A closer inspection of the can showed that this was corroded on one side, which may have caused the damage to the plastic tubing.

Immediate Action: The researcher immediately removed their nitrile gloves in the fume hood, and washed their hands thoroughly with soap and water.

Researchers in the lab were alerted and the fume hood containing the corroded can was taken out of use until the can with bromine was correctly disposed of via EHS.

Recommendations: Check chemical inventory and chemical containers regularly and dispose of old, unwanted chemicals, or of those found in damaged containers via EHS. If unsure of how to handle a damaged chemical container, or need guidance on how to dispose of the chemical, please reach out to EHS Hazardous Waste Disposal team at 765-494-0121.

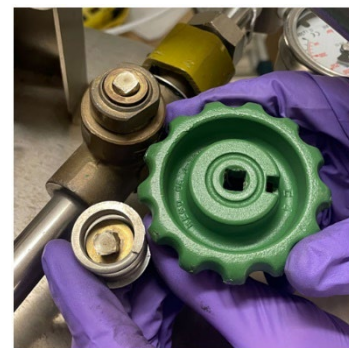
3. March 12, 2024 – Damaged “Gas use” valve on LN2 tank

Description: While trying to connect a LN2 tank to a glove box, two researchers were unable to open the “gas use” valve, needed for glove box operation. The valve was not frozen closed. A third researcher tried to open the valve too, but was also unsuccessful. The researcher then used a monkey wrench to try to loosen the valve, but due to the force applied the knob for the valve and the stem that connects it to the valve sheared in two pieces, leaving the valve permanently shut (see photo to the right).

Nitrogen gas rapidly expands to approximately 700 times its liquid volume, displacing oxygen and posing a significant asphyxiation hazard. Skin contact with the liquid can result in serious burns. Although in this case there was no uncontrolled release of nitrogen in the lab, the potential release was present due to the broken valve on the tank.

Immediate Action: All debris were placed on the benchtop nearby. No sharp objects or sharp pieces were created when the knob sheared in two. The tank was used for liquid dispense only, and once emptied it was sent for repair.

Recommendations: The incident occurred due to tools being used to open a valve. When the gas (or liquid dispensing) valve on a LN2 tank becomes difficult to open by hand, it is an indication that the equipment requires repair. **Tools must never be used to force a valve open.** Other indicators that repairs may be needed include: (1) Corrosion or damage to the cylinder body or valves, (2) Broken or inaccurate gauges, (3) Loss of product due to insufficient vacuum insulation, (4) Frequent venting of gas through the pressure release device, (5) Frost formation on the valve handles or tank body.
